Report No. 0270-07-17309

Testing and Examination of Pipe from
Dixie Pipeline Company's
12-inch Hattiesburg, MS to Demopolis, AL Pipeline

T. V. Bruno

March 30, 2007

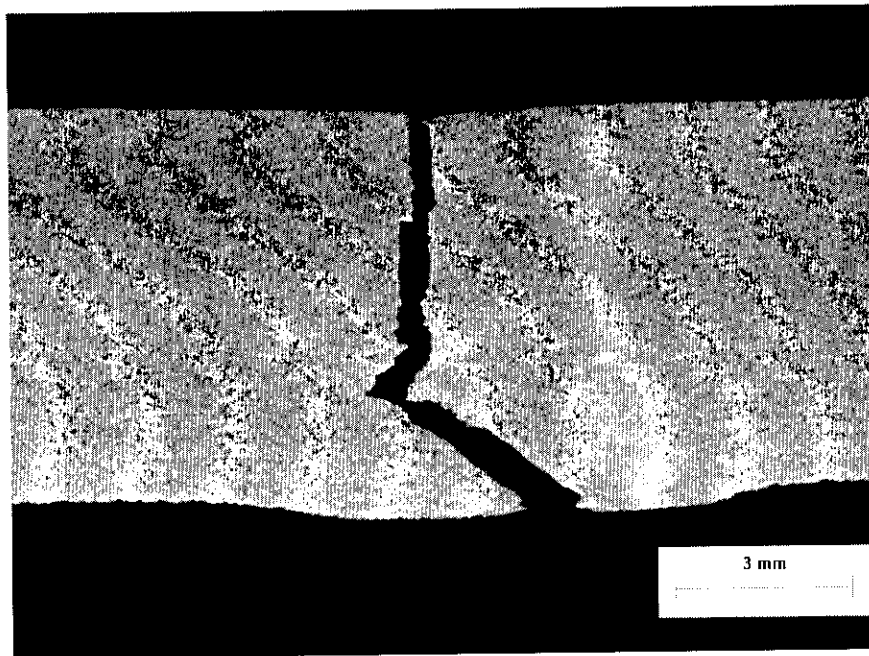
Figure 96

Photograph showing a large hook crack at the fracture origin.

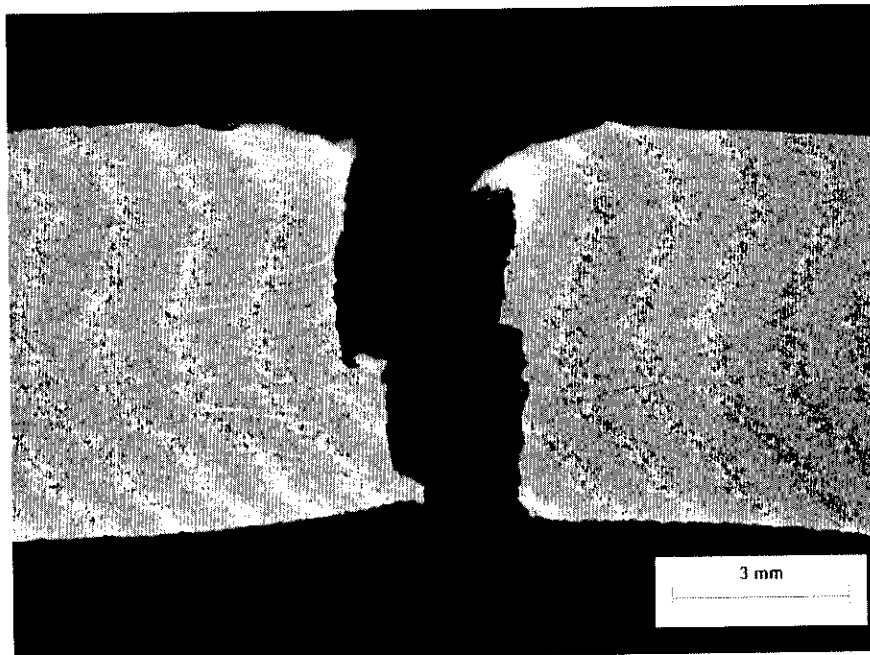
Photograph showing a hook crack at the likely failure origin.

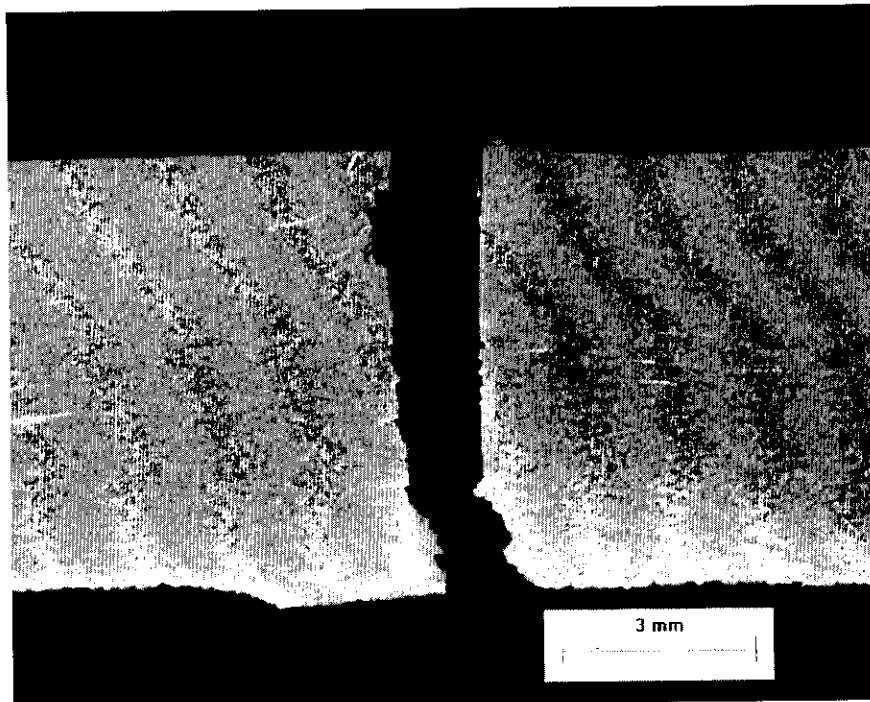
Figure 106 shows a hook crack, multilayered fracture and black spots at a bulge near the center of the rupture, and Figure 107 shows the deepest flaws, arrows, found along the rupture.

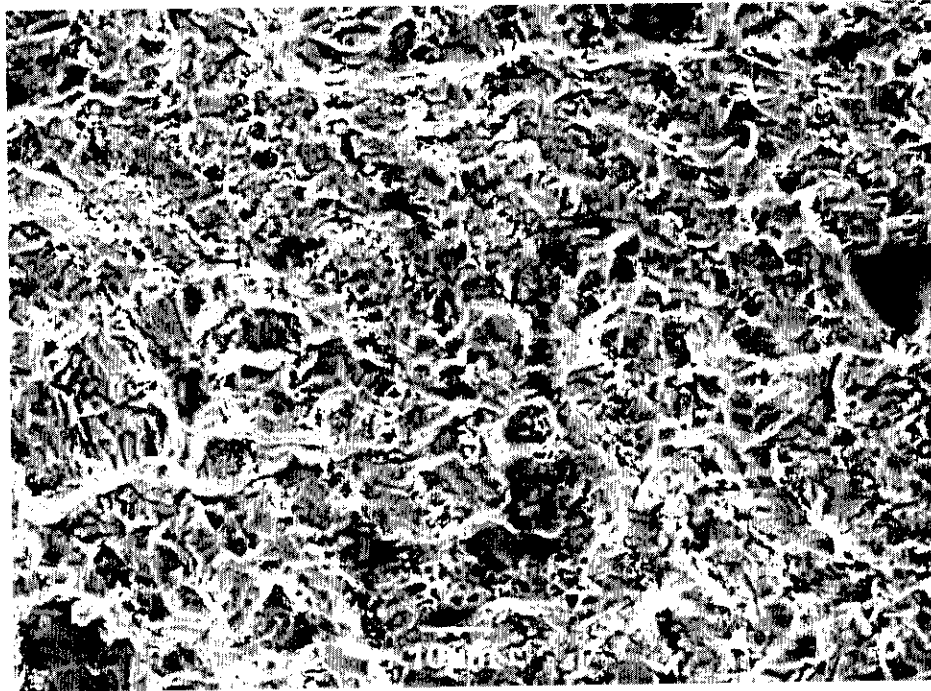
Macrograph of the area to the right of the failure origin in Joint No. 332.

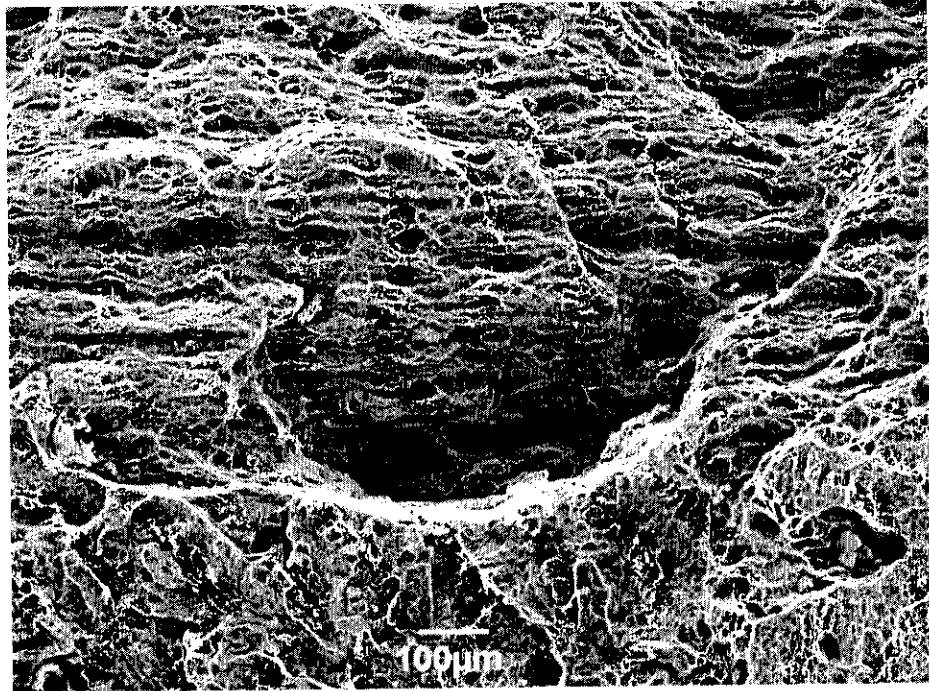
Figure 115 shows a large area of woody fracture, and Figure 116 shows a typical location at higher magnification.

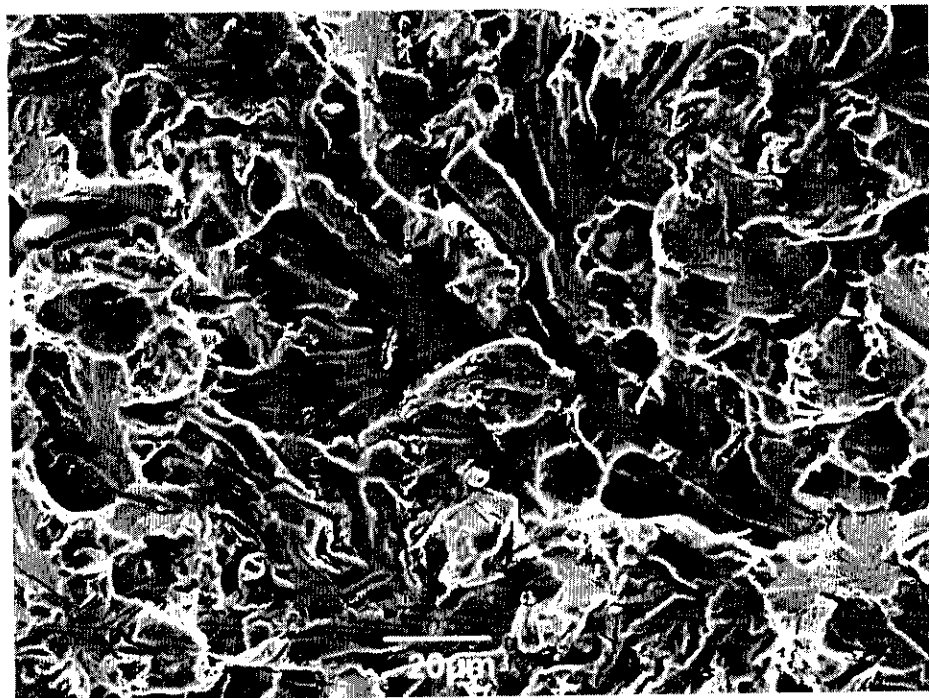
Figure 117

Transition from woody fracture, at top, to cleavage fracture at bottom.

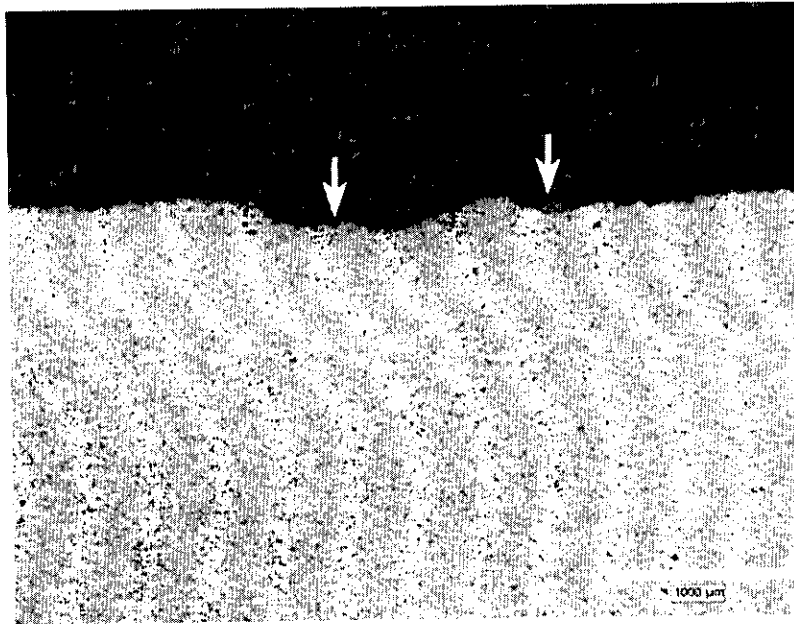
Typical magnetic particle indications found adjacent to the weld of Joint No. 6418. The arrows indicate a shallow groove and tool marks from flash trimming.

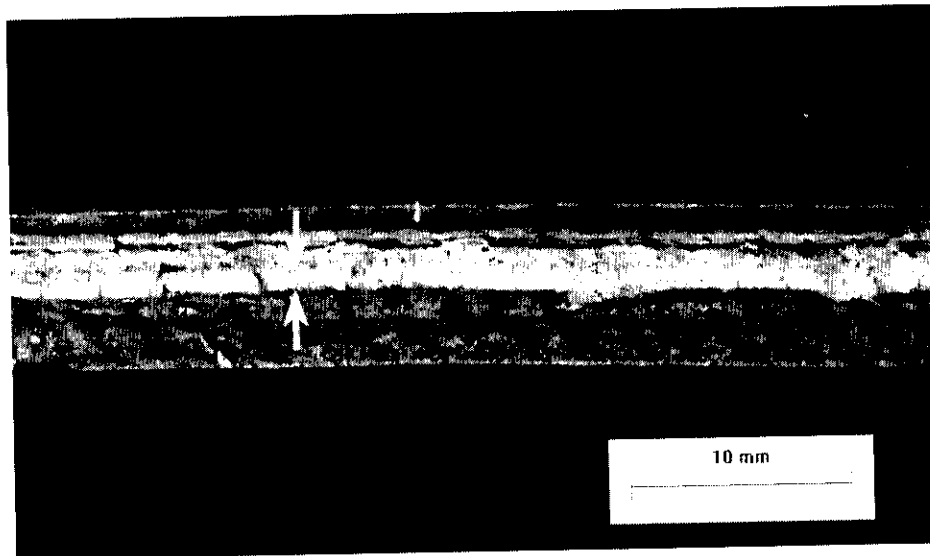
Photograph of the hook crack near the downstream end of the rupture, arrow.

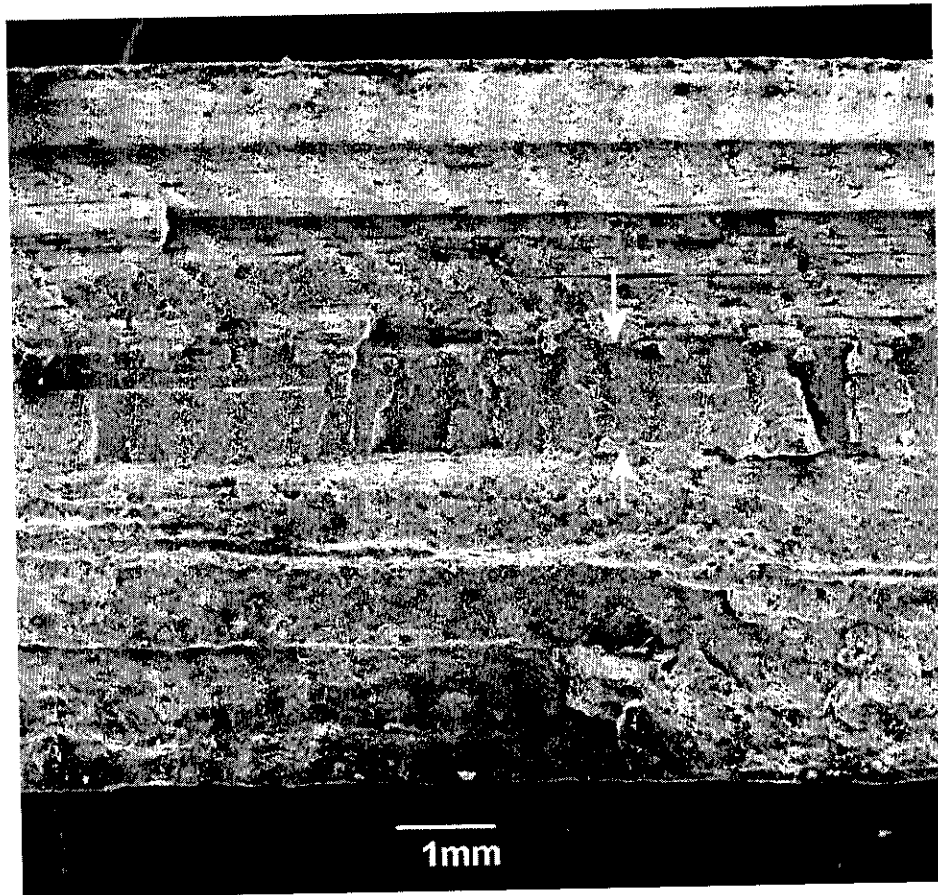
7. Visual and fractographic examinations of the fracture surface from the fatigue test showed a small area with fracture characteristics that were likely due to fatigue crack propagation.

Close-up views of part of the fracture with suspected fatigue markings, between arrows.

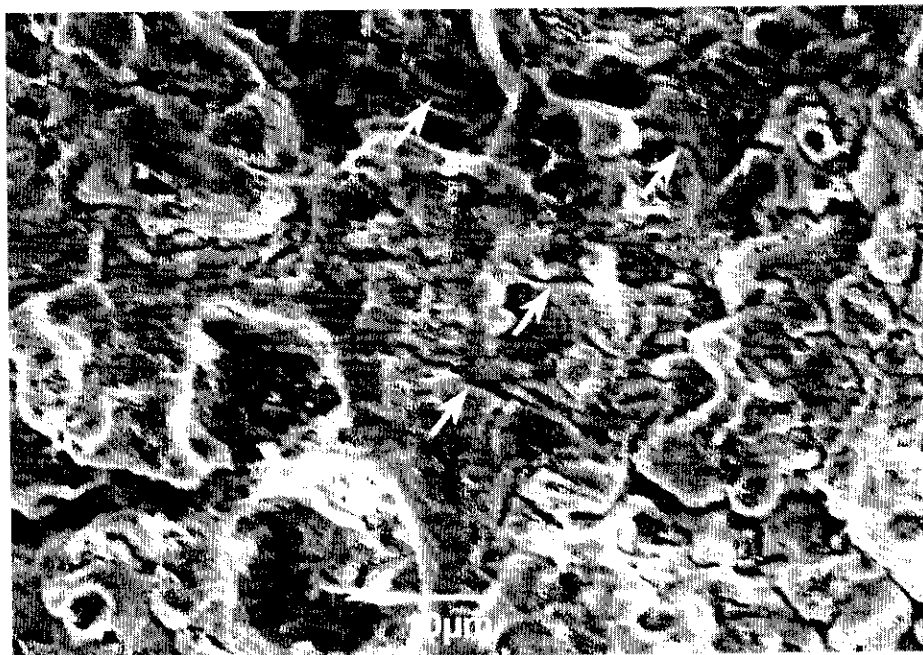
Electron micrograph of the fracture toward the outside surface. The letters indicate features shown in subsequent figures.

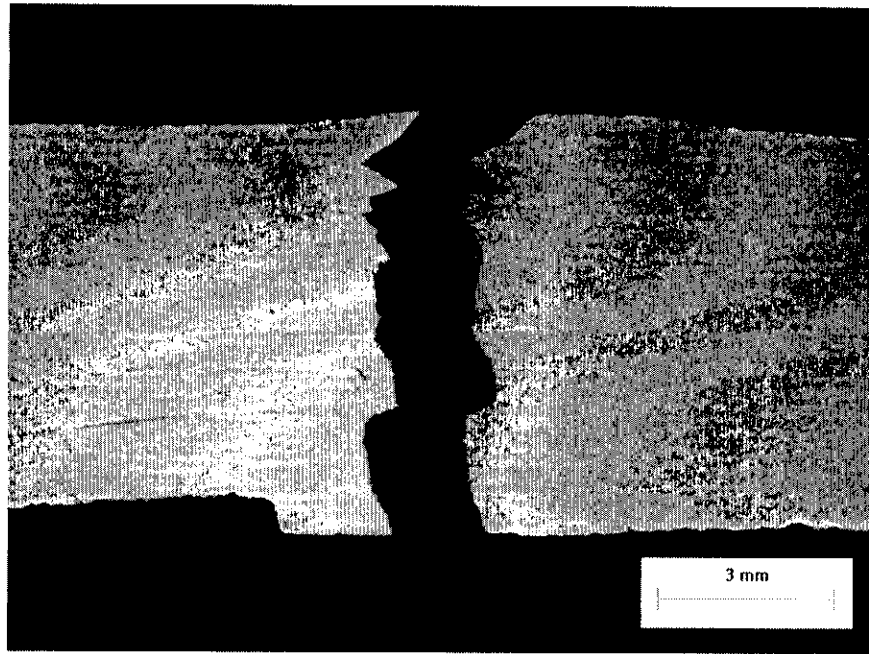
Figures 139 and 140 show representative areas of tearing and cleavage, respectively.

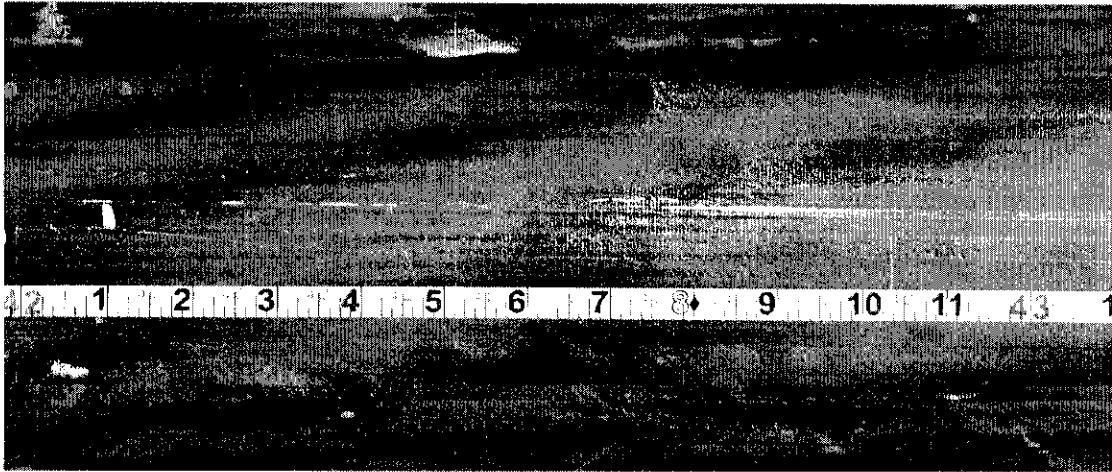
Figure 145 shows the fracture near midwall with an arrow indicating the flat fracture examined in the SEM, and Figure 146 shows the flat fracture at higher magnification.
